SERVICE BULLETIN #94-01

**TO: ALL USERS OF ELLISON FLUID SYSTEMS, INC. THROTTLE BODY
INJECTORS**

SUBJECT: Excessive wear of throttle ball swivel fitting.

MODELS AFFECTED: All Models SERIAL NUMBERS AFFECTED: All

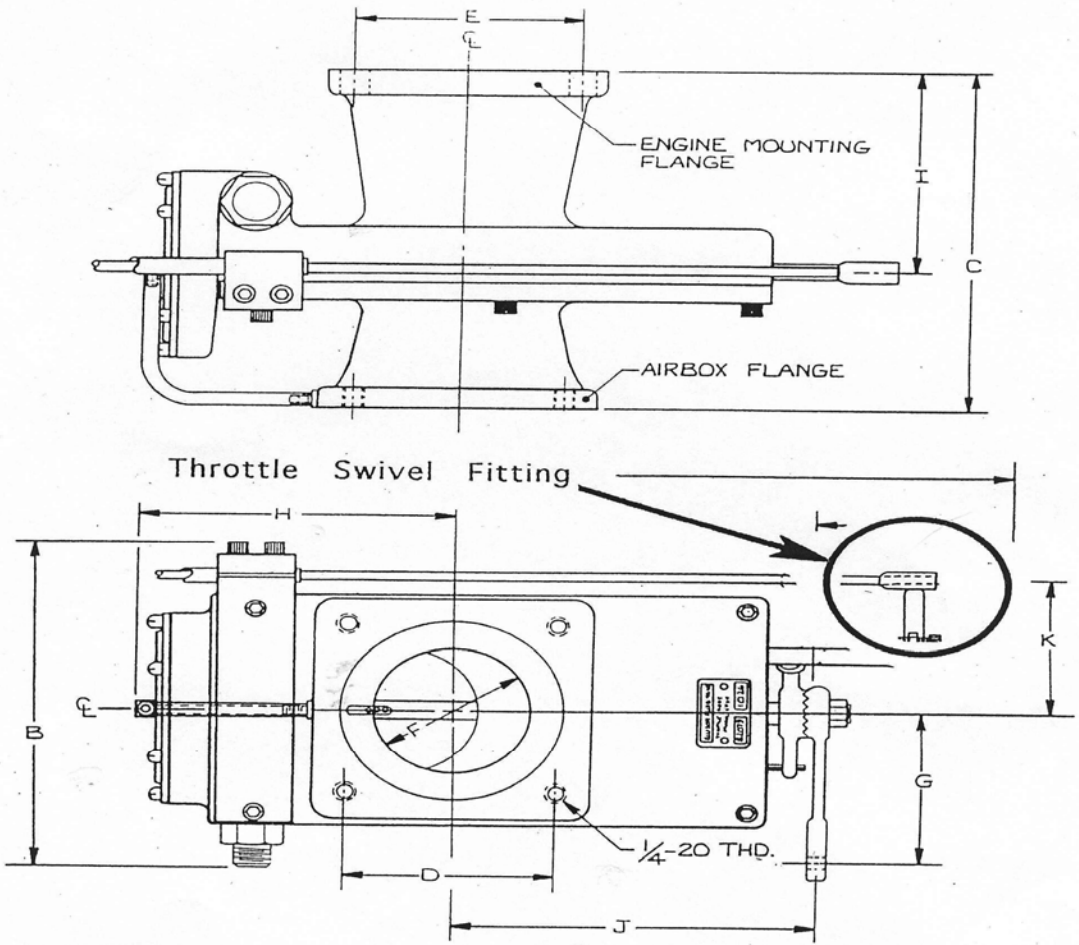
Ellison Fluid Systems, Inc. has discovered two instances of excessive wear of the ball swivel fitting which connects the throttle linkage to the Throttle body Injector throttle shaft. See attached Fig. 1 for location of the swivel fitting. These two worn fittings were found on aircraft with rod type throttle linkages. Inflight throttle linkage disconnect with resulting engine failure will occur if this wear continues uncorrected.

1. See figure 1 for the location of the swivel fitting.
2. Disconnect the ball swivel fitting from the throttle shaft by removing the snap ring and sliding back the spring loaded retention collar (see figure 2 and 3).

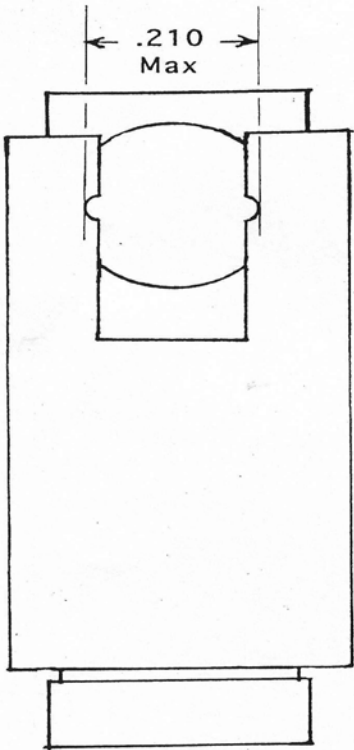
Fig. 2

3. Examine the slot machined in the retention collar for wear. Figure 2 illustrates the wear caused by the throttle shaft and shows the maximum permissible wear caused by the throttle shaft. Figure 3 shows maximum permissible wear in the retention collar caused by the ball. If the swivel fitting is worn beyond either of the above specified limits, it must be replaced with a new fitting before further flight. This swivel fitting is P/N 14-003 and the spring clip is P/N 33-005; both are available from Ellison Fluid Systems, Inc.

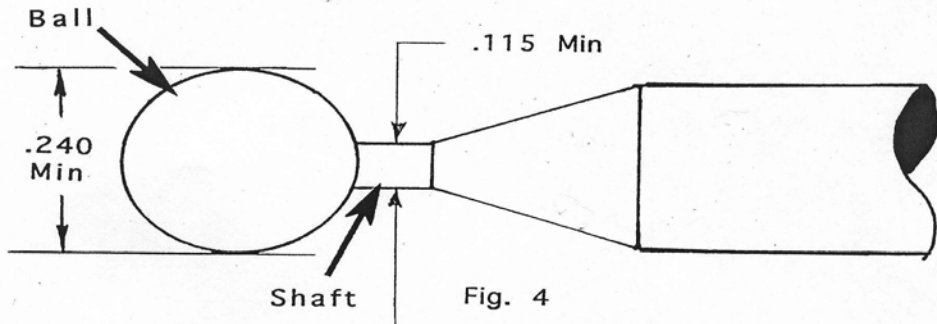
Fig. 4

4. Figure 4 shows maximum permissible wear of the ball and throttle shaft. If either the ball or the throttle shaft is worn beyond the limits specified in figure 4, the throttle shaft of the injector must be replaced. This part is not field serviceable. For repair, please send the unit in to Ellison Fluid Systems, Inc. to the letterhead address.
